## THE IMPLICATION OF THE FACULTY OF ARCHITECTURE AND CONSTRUCTIONS IN THE REHABILITATION PROCESS OF ORADEA FORTRESS

eng. Othilia GROZA

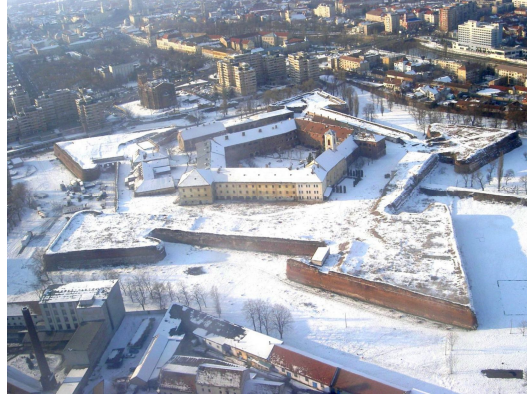
**Figure 2. The monumental anseble**

The monumental ensemble (Figure 2) is comprised of:

- the defensive wall with five bastions, two gates and the moat with counterscarp (1570–1618);
- the pentagonal construction which includes the former princely palace (marked A, B, C), the baroque church (D) and barracks (E), (1638-1780);
- thirteen annex buildings (marked F...M): bakery, casemates, customs, stables, the officers' barracks, etc.

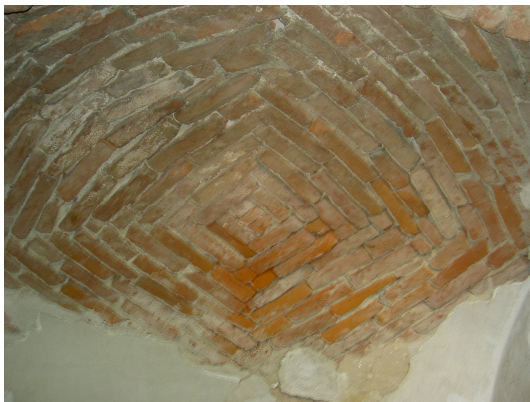
Figure 3. Brick masonry vault.

**The predominant construction material** in the fortress is brick- and stone-masonry used ingeniously both in the case of walls as vaults (Figure 3.), arcades, slabs, plinths and foundations (Figure 4).

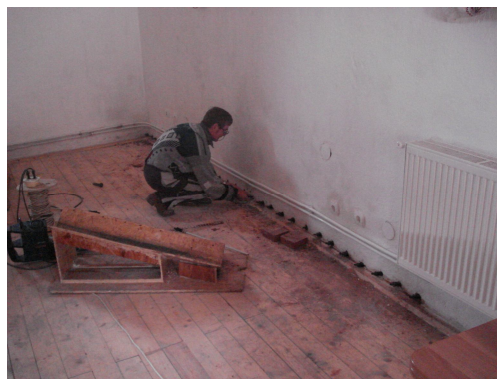
Figure 5. Drilling holes

To reduce the discomfort and the permanent disintegration of the masonry materials due to high humidity, a structural treatment with silicone micro-emulsion was done for the horizontal waterproofing in the conference centre from block J. The walls have a medium thickness of ~160 cm and consist of brick-masonry with a porous stone nucleus, with lime mortar joints.

- Securing efficiency by treating the wall simultaneously on both sides;
- Determining the grouting level – as close to the ground as possible;
- Positioning and marking the place of the orifices, which will be drilled – at a distance of ~20 cm from each other (Figure 5.);
- Drilling the wholes with a 18 mm bit, with a length of 70 cm in an oblique direction from up towards down;
- Removing the fine dust (powder from destroyed construction material) from the orifices, cleaning with compressed air or a vacuum cleaner;
- Introducing the special plastic tubes, with the help of which the grouting will be executed (Figure 6.);
- Preparing the grouting instrument and the system of tubes belonging to it (Figure 7.);
- Carrying out the grouting at 4,5 atm and disassembling the instrument (Figure 8.).
